D6.4: Monitoring systems set up in demonstration projects and running

OUTPHIT – DEEP RETROFITS MADE FASTER, CHEAPER AND MORE RELIABLE

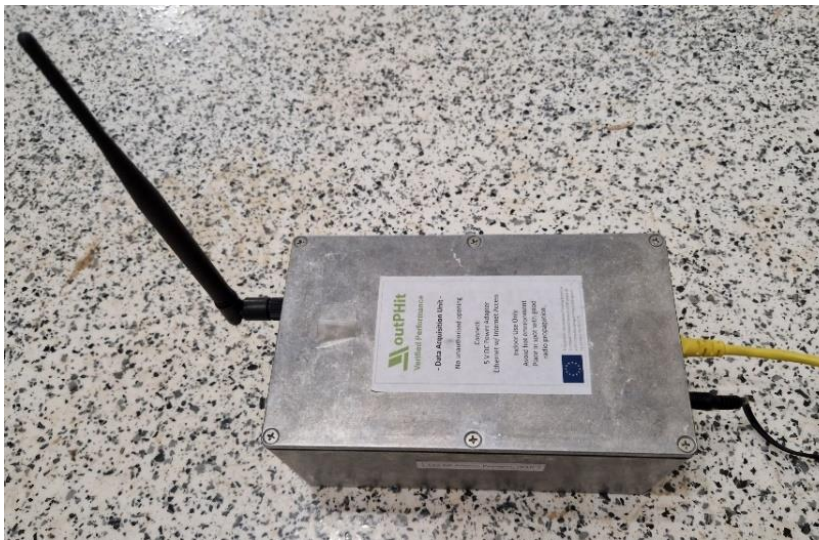
The DAU includes a variety of components with the main component being the concentrator of LoRa wan,

- Antenna: to receive signals from the metering devices
- Ethernet bridge: to connect the unit to the internet and upload all the monitoring data to the online platform
- Power supply

Figure 1 The DAU ©Hellenic Passive House Institute

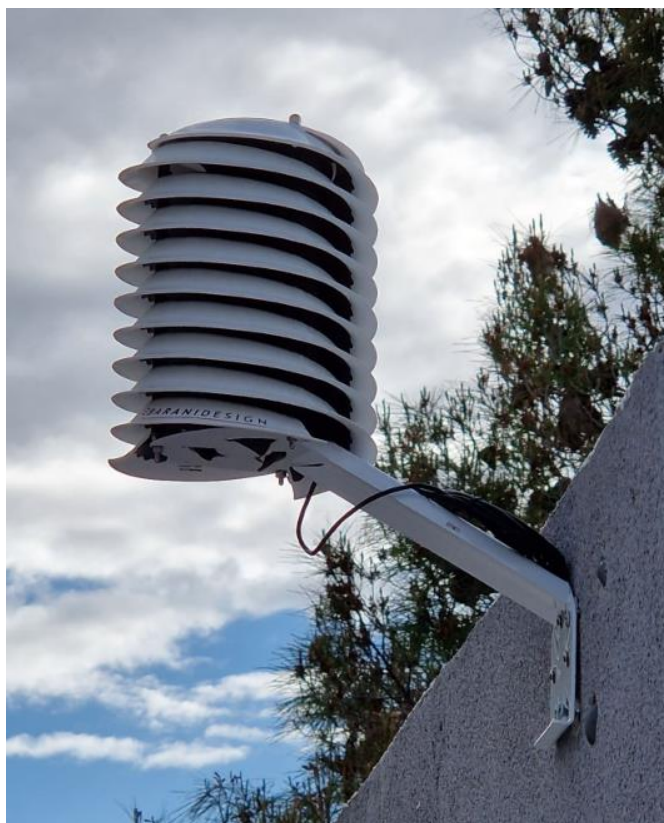
Figure 2 The weather station installed in case study 2 ©Hellenic Passive House Institute

The weather station is a self-powered device equipped with LoRa Wan communication protocol, capable of measuring the exterior temperature, relative humidity, CO₂ concentration and the radiation.

The weather station should be installed in a shaded free place and should be taken care periodically by cleaning the exterior PV panel to measure correctly the radiation and to be able to charge in order to function.

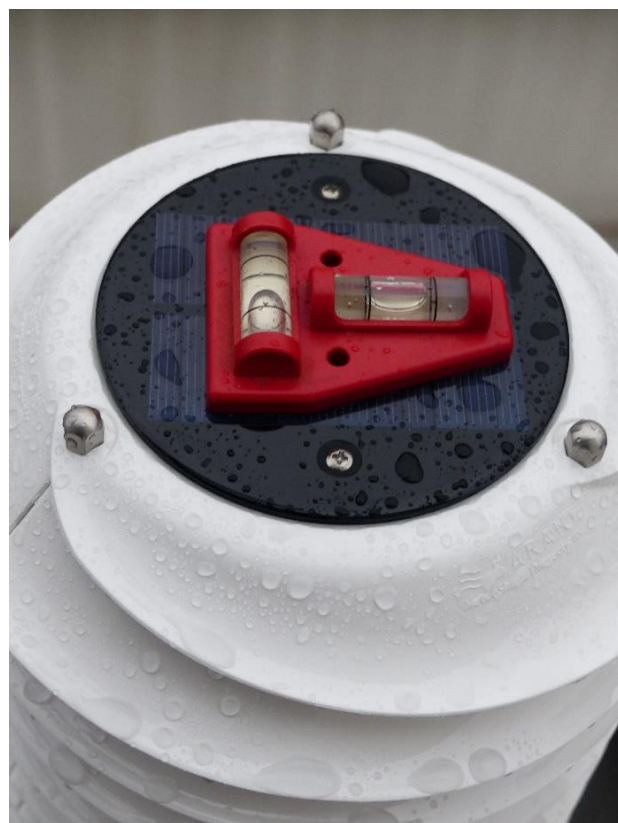
Figure 3 The weather station during installation with spirit level ©Barani Design

Finally, it is crucial to be installed completely straight in both directions, so a spirit level should be used.

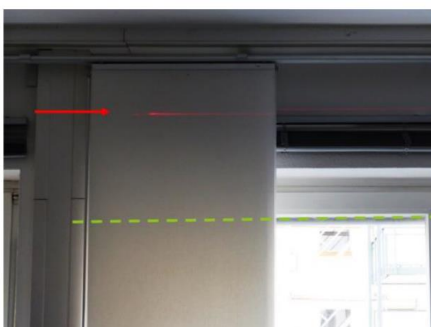
Figure 4 The IAQ sensors been placed on case studies ©Passive House Institute

The internal air quality sensors should be installed in interior walls only, should be in a height of more than 1,1m from the floor and away from direct solar radiation and internal heat sources.

They meter the temperature, relative humidity, CO₂ and they are supplied by batteries.

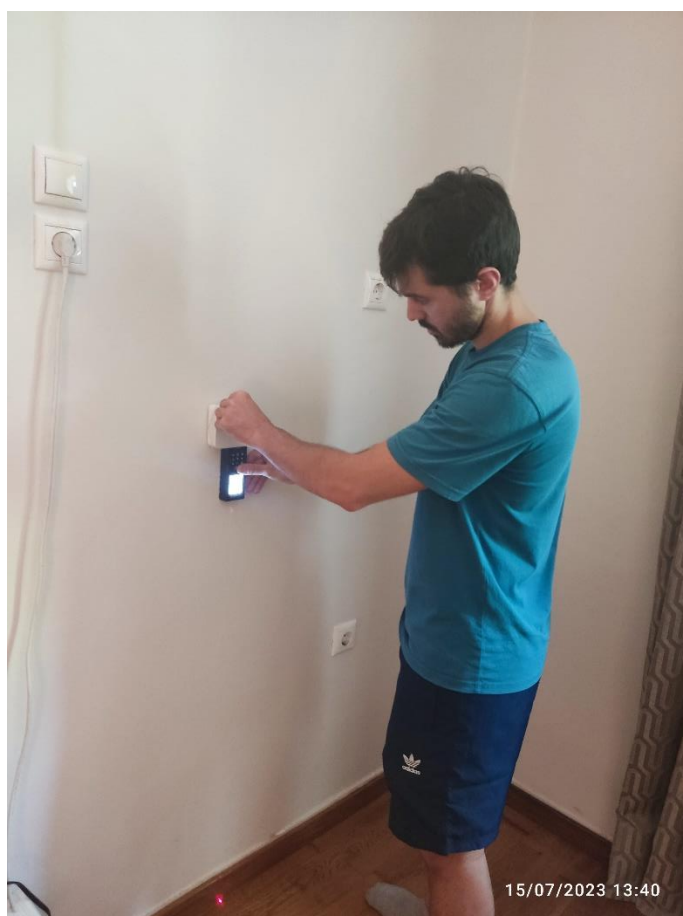
Figure 5 The IAQ sensors been placed on case study 4 ©Hellenic Passive House Institute

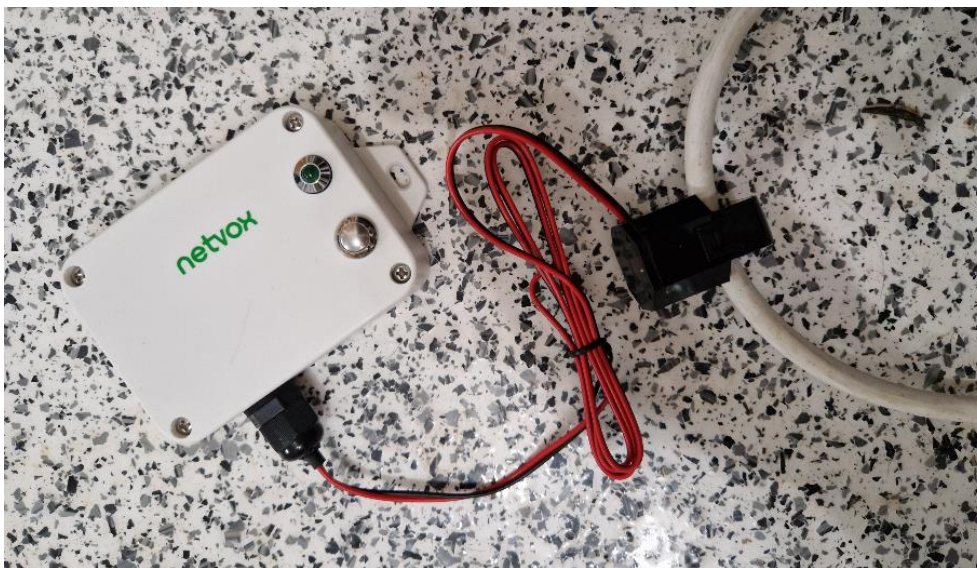
Figure 6 The netvox energy meter being tested in our office ©Hellenic Passive House Institute

They are installed within the utility meters to measure electricity consumption using magnetic cable sensors. Powered by batteries, they transmit the metering data via the LoRaWAN communication protocol.

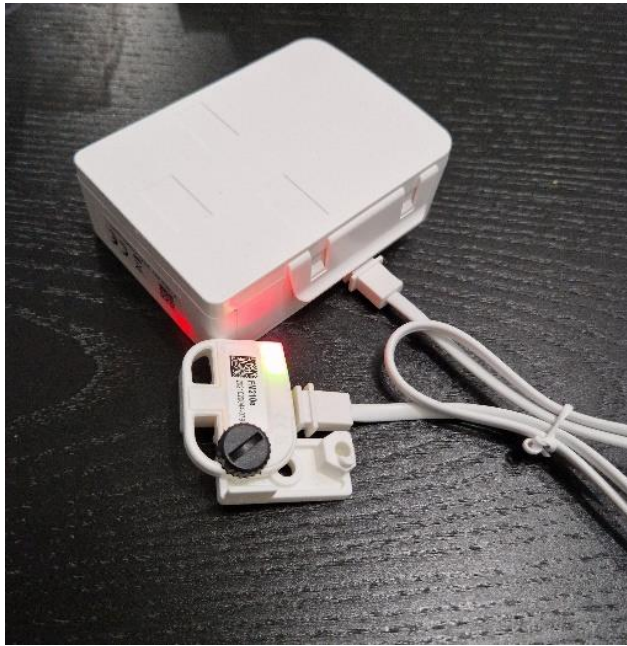
Figure 7 The Fludia energy meter tested in our office ©Hellenic Passive House Institute

The Fludia metering devices measure energy consumption; however, unlike the Netvox devices, they are installed directly on the utility meter and capture either the meter's revolutions or LED pulses.

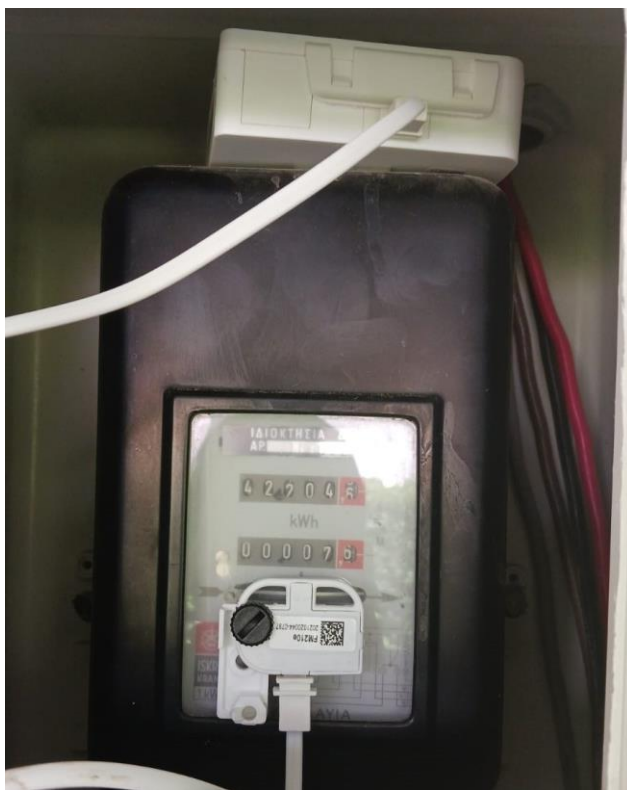
Figure 8 The Fludia energy meter being installed on case study 2 ©Hellenic Passive House Institute

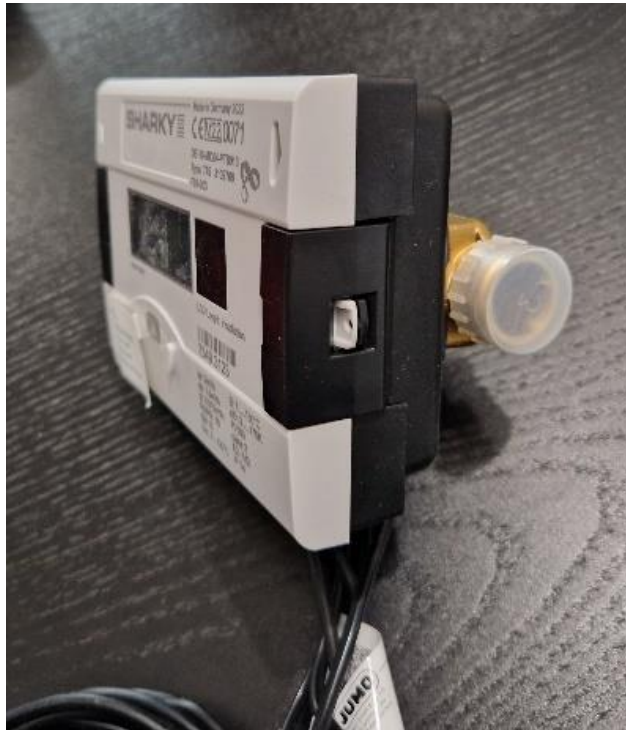
Figure 9 The Sharky 775 ultrasonic energy meter ©Hellenic Passive House Institute

The solar domestic hot water production will be measured by the Sharky devices, which are equipped with a thermocouple to measure water temperature and a magnetic flow meter. These devices are battery-powered and communicate via the LoRaWAN protocol. The ultrasonic compact energy meter can also be used to measure energy consumption in heating and cooling applications for billing purposes.

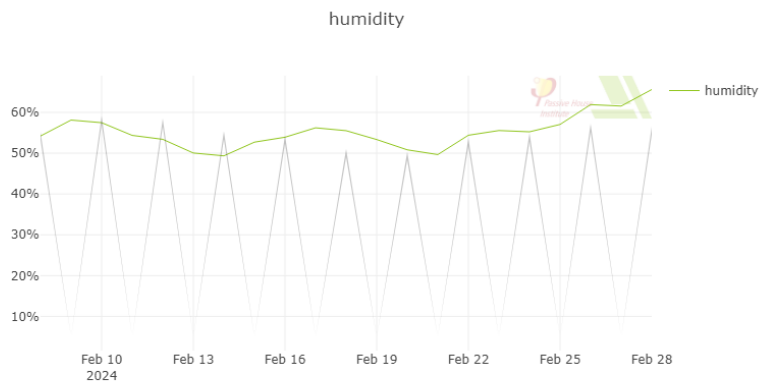
Snapshots from the online platform for case study 2, located in Papagos, Athens, reveal that the project—a certified Passive House **EnerPHit**—demonstrates ideal indoor air quality and superior comfort, as confirmed by both the measurements and the tenants' feedback. Notably, the average indoor temperature during winter remains below the 20°C threshold considered in the Passive House standard for energy demand calculations, a choice entirely driven by the tenants, who feel comfortable even at 18°C. Additionally, the relative humidity and CO₂ concentration levels are consistently maintained within excellent ranges.

Figure 10 Indoor air humidity at case study 2 over a specific period © Hellenic Passive House Institute

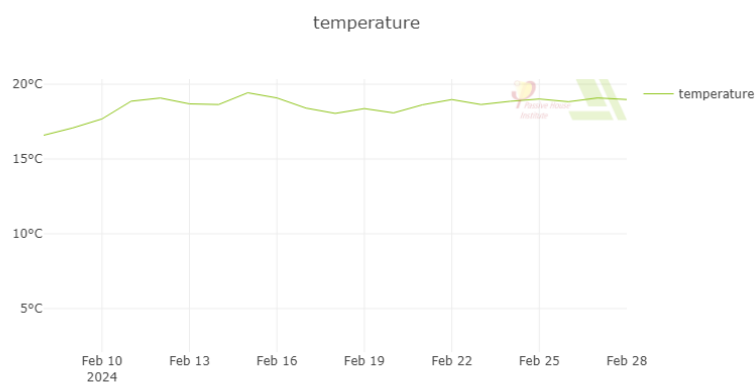
Figure 11 Indoor temperature at case study 2 over a specific period © Hellenic Passive House Institute

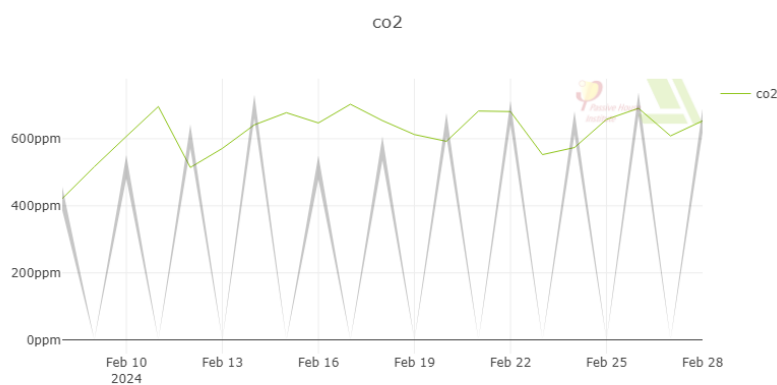
Figure 12 Indoor CO₂ concentration at case study 2 over a specific period © Hellenic Passive House Institute

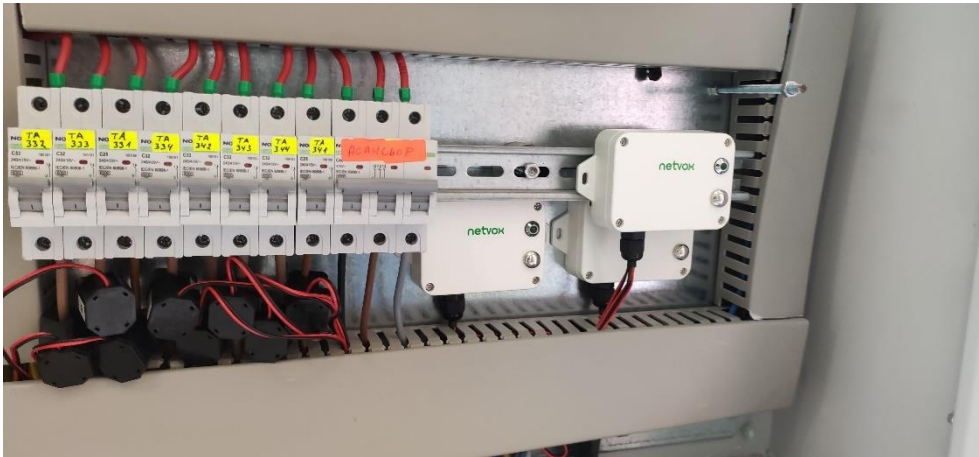
Installation of the Netvox electricity meters at the OP32 Burgas Observer Project.

Figure 13 The Netvox energy meters installed at the OP32 Burgas Observer Project © EnEffect

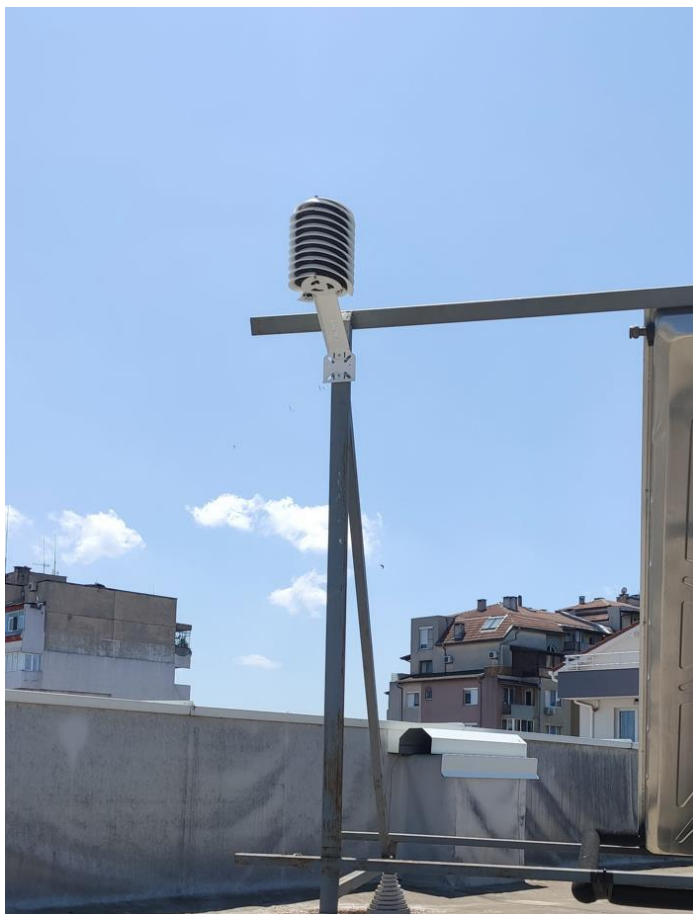
Installation of the weather station at the OP32 Burgas Observer Project.

Figure 14 The Barani Design weather station installed at the OP32 Burgas Observer Project © EnEffect

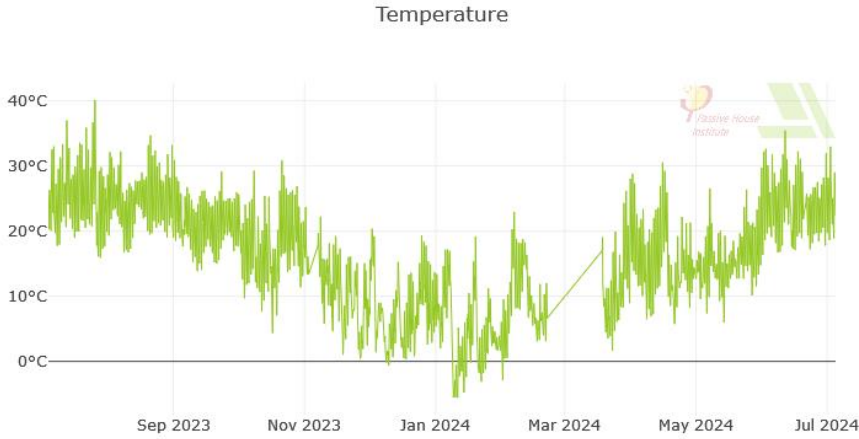
Data is available for the 2023/2024 period. Outdoor temperatures were markedly milder than the climate data for the location suggest, the availability of solar radiation was slightly lower than average. Due to the coastal location relative humidity of outdoor air was high year-round.

Figure 15 Outdoor air temperature in the period under consideration © EnEffect

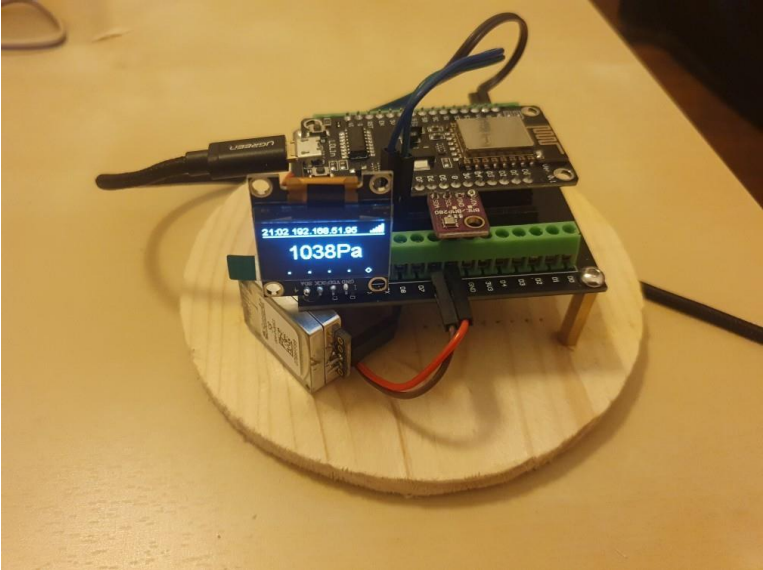
Atmospheric pressure measurement:

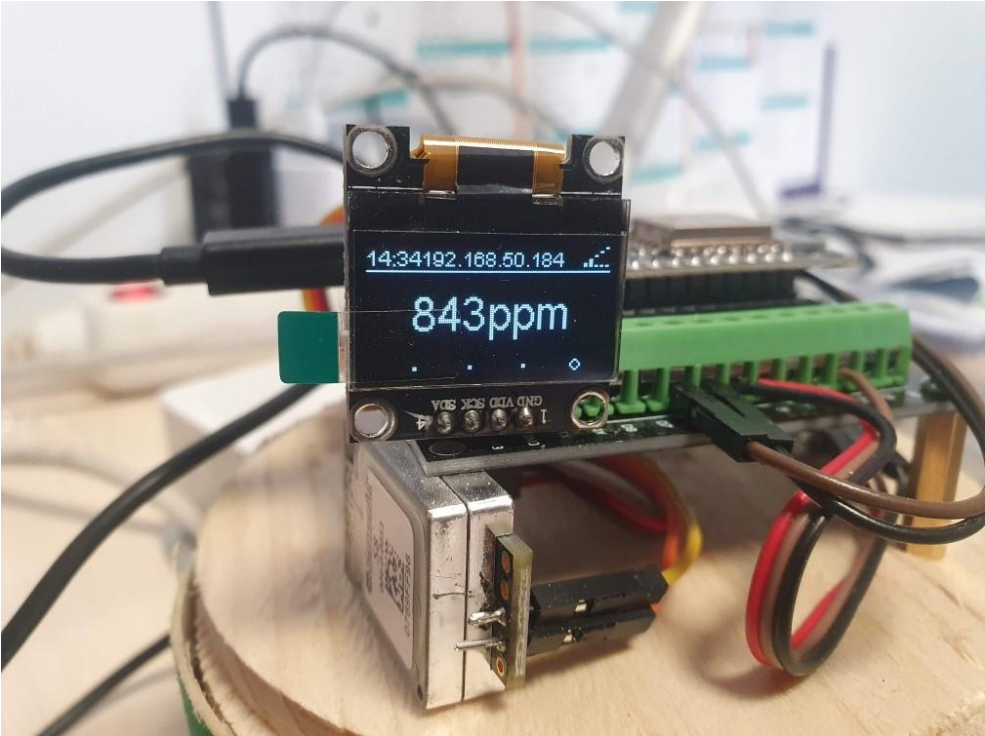
And CO₂ concentration:

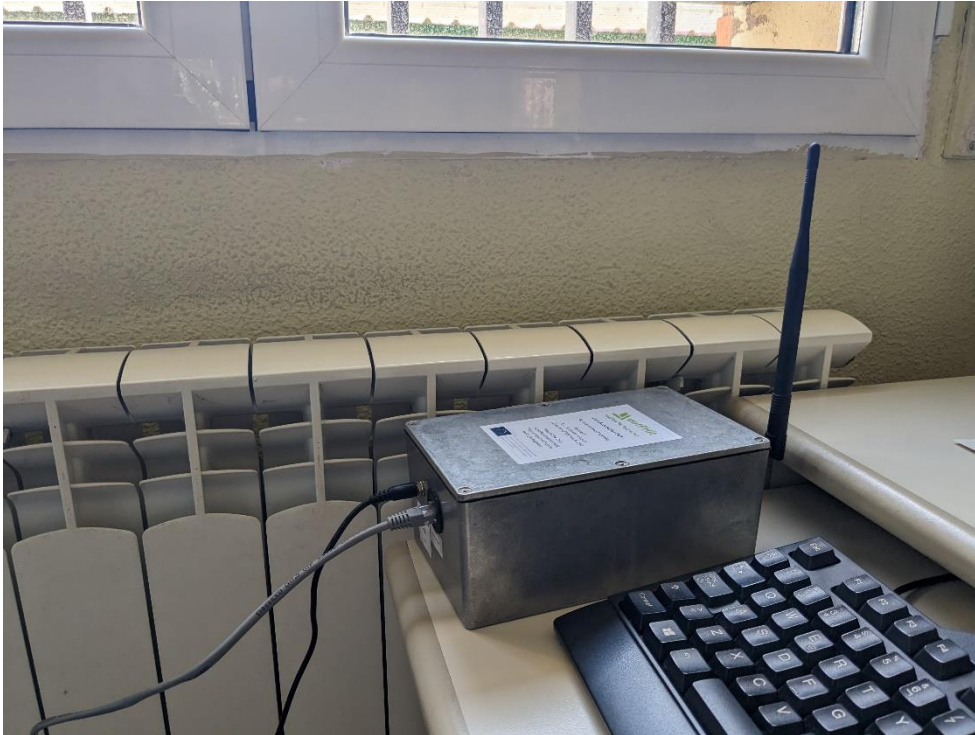
The DAU:

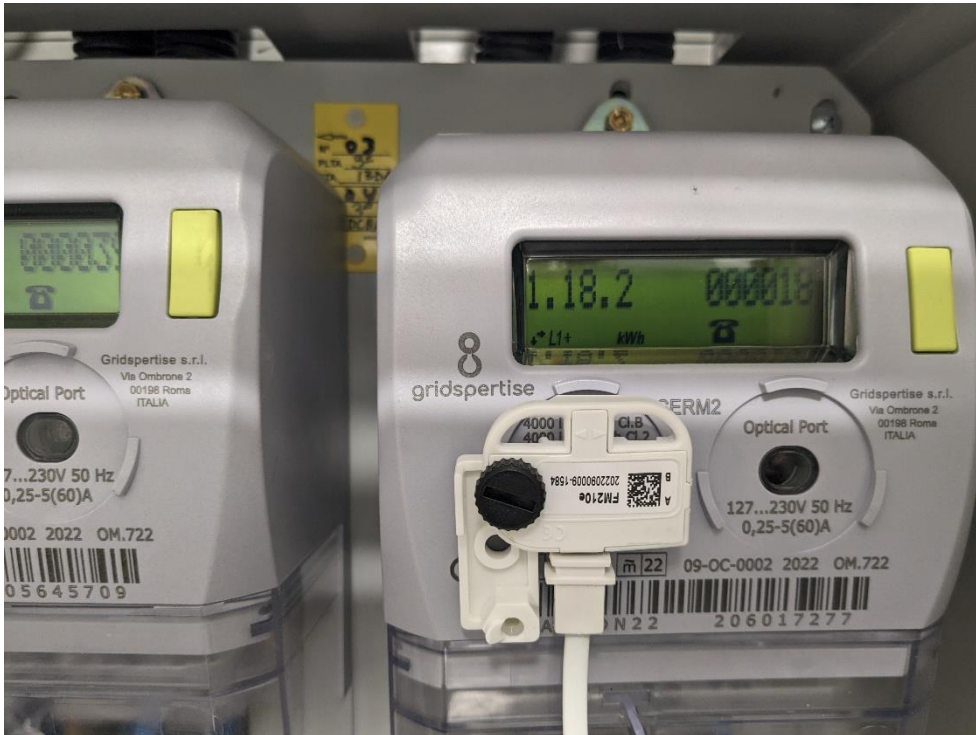
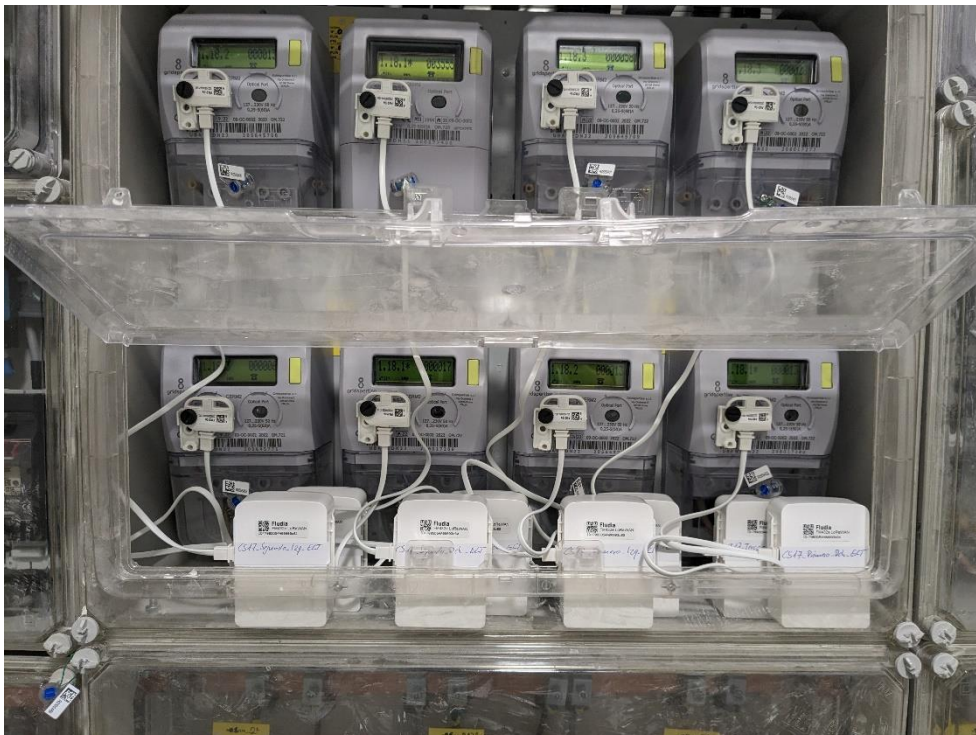
The electricity meters:

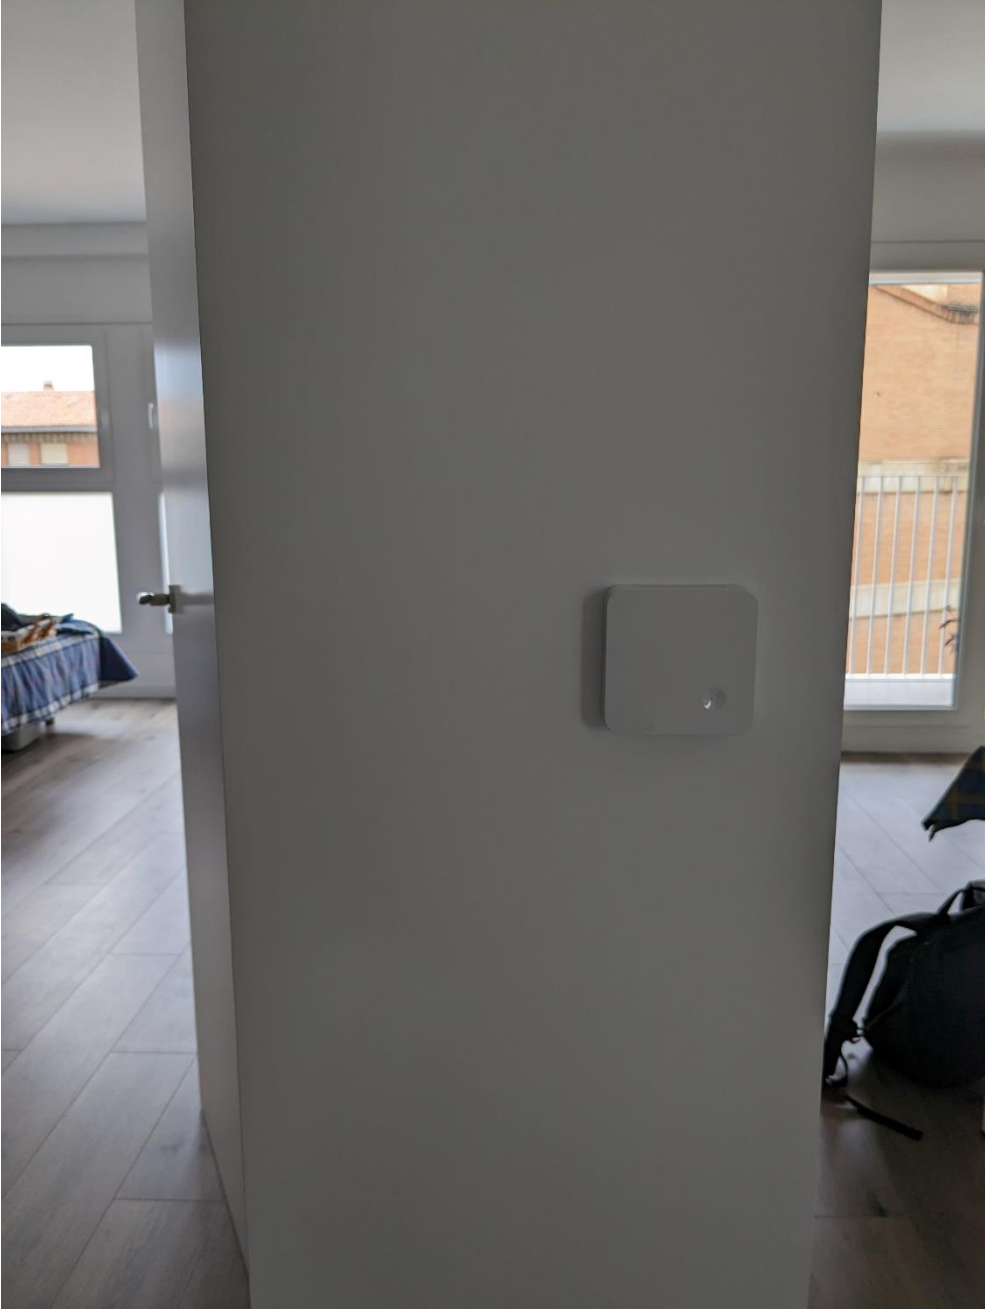
The IAQ sensors:

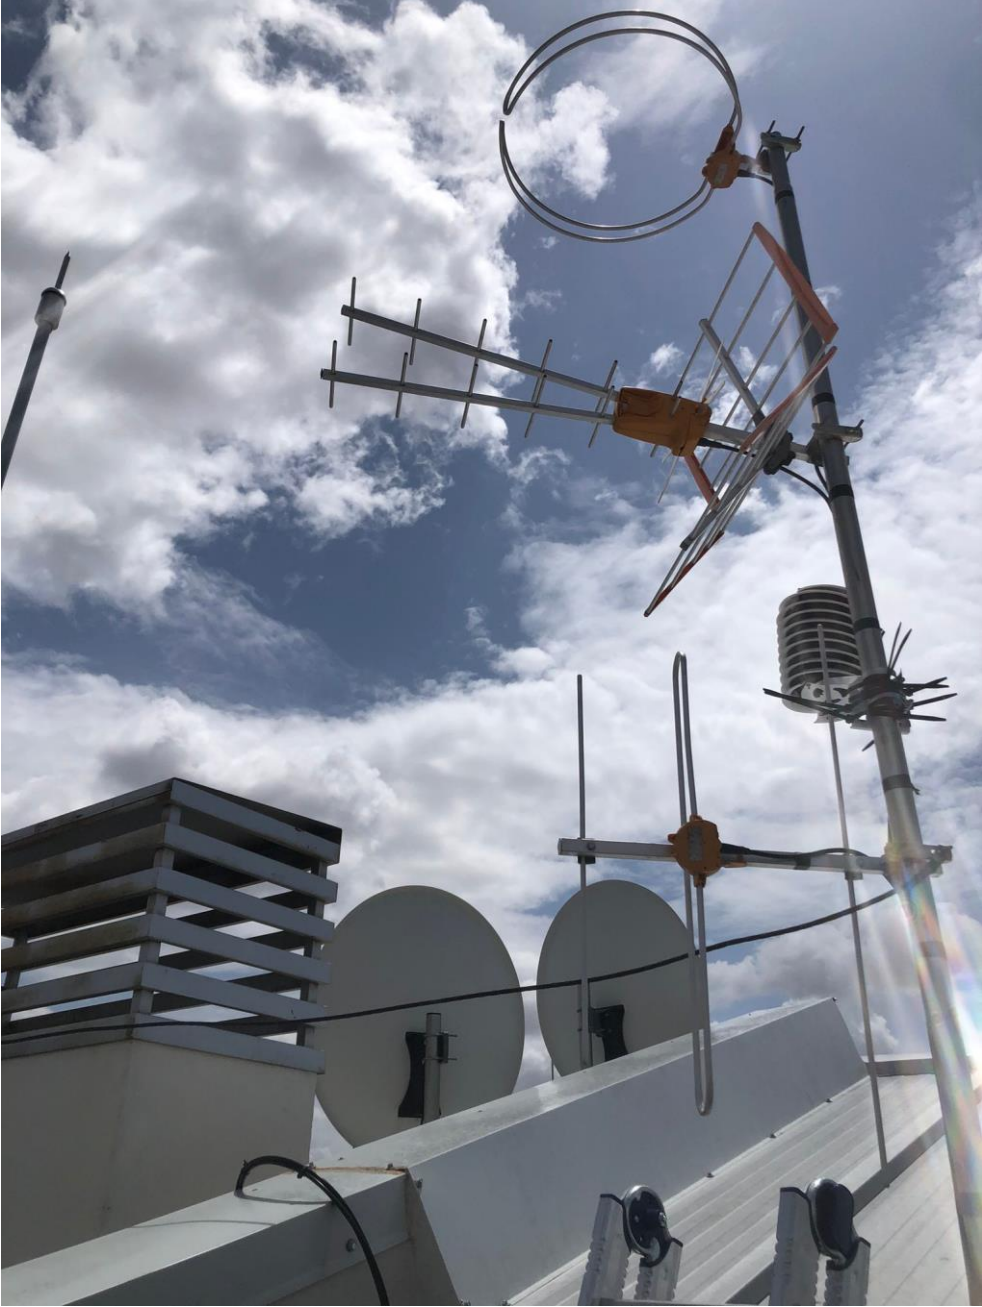
And the weather station:
