GR CS2: Papagos, Athens

RENOVATION APPROACH DOCUMENT

Deliverable D5.2

Renovation Approach Description

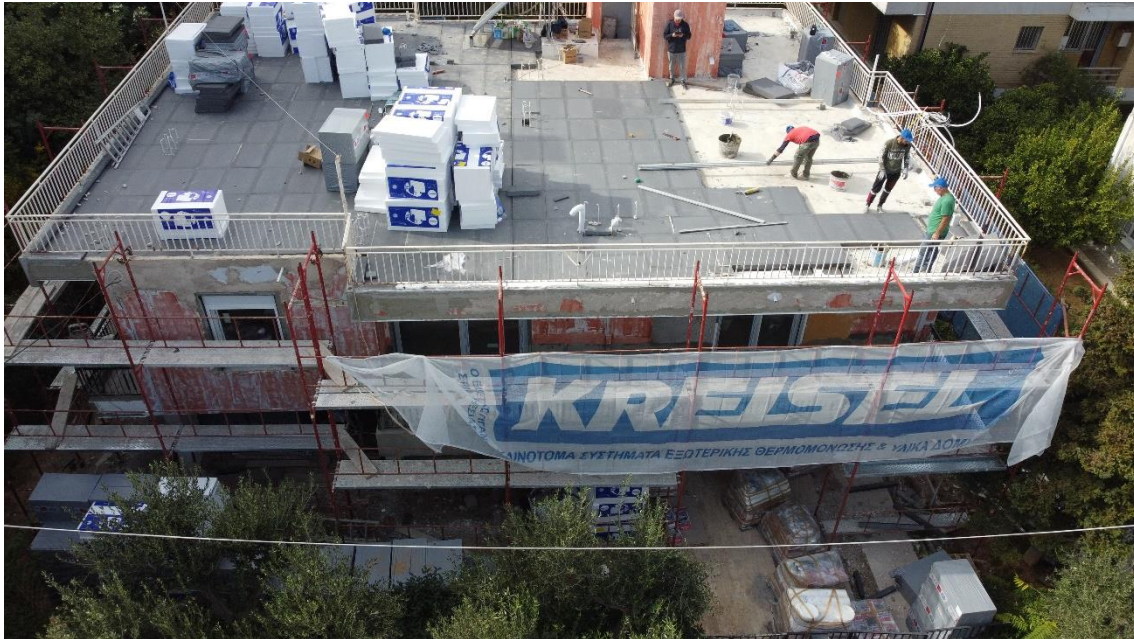
Figure 1 Photo taken during the installation of the roof insulation

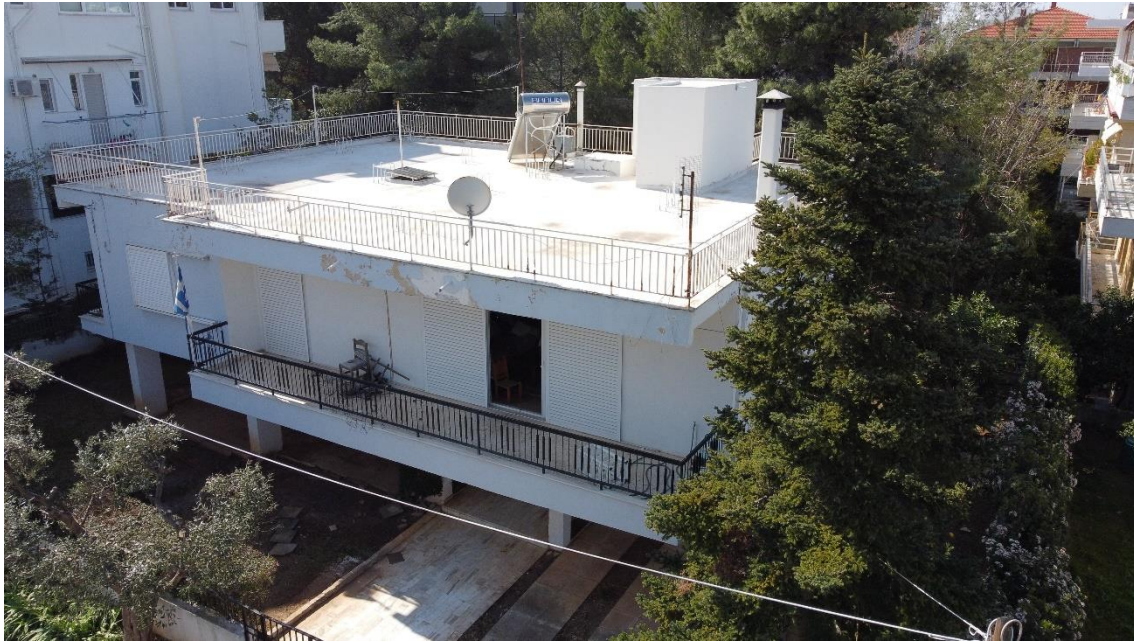
Figure 2 The existing building before the renovation

The existing building has a massive construction with pillars and columns from reinforced concrete and brick-concrete walls. The envelope was completed non insulated. The situation of the building was moderate as there were many building elements with mold and bad external surfaces.

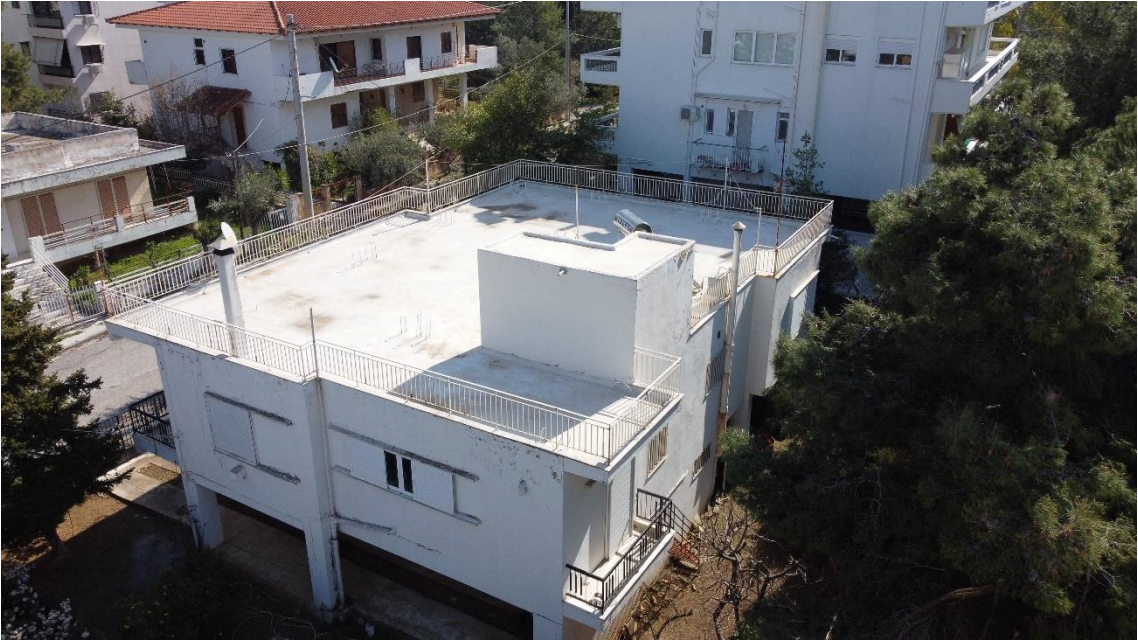
Figure 5 The southeast and southwest elevations of the building

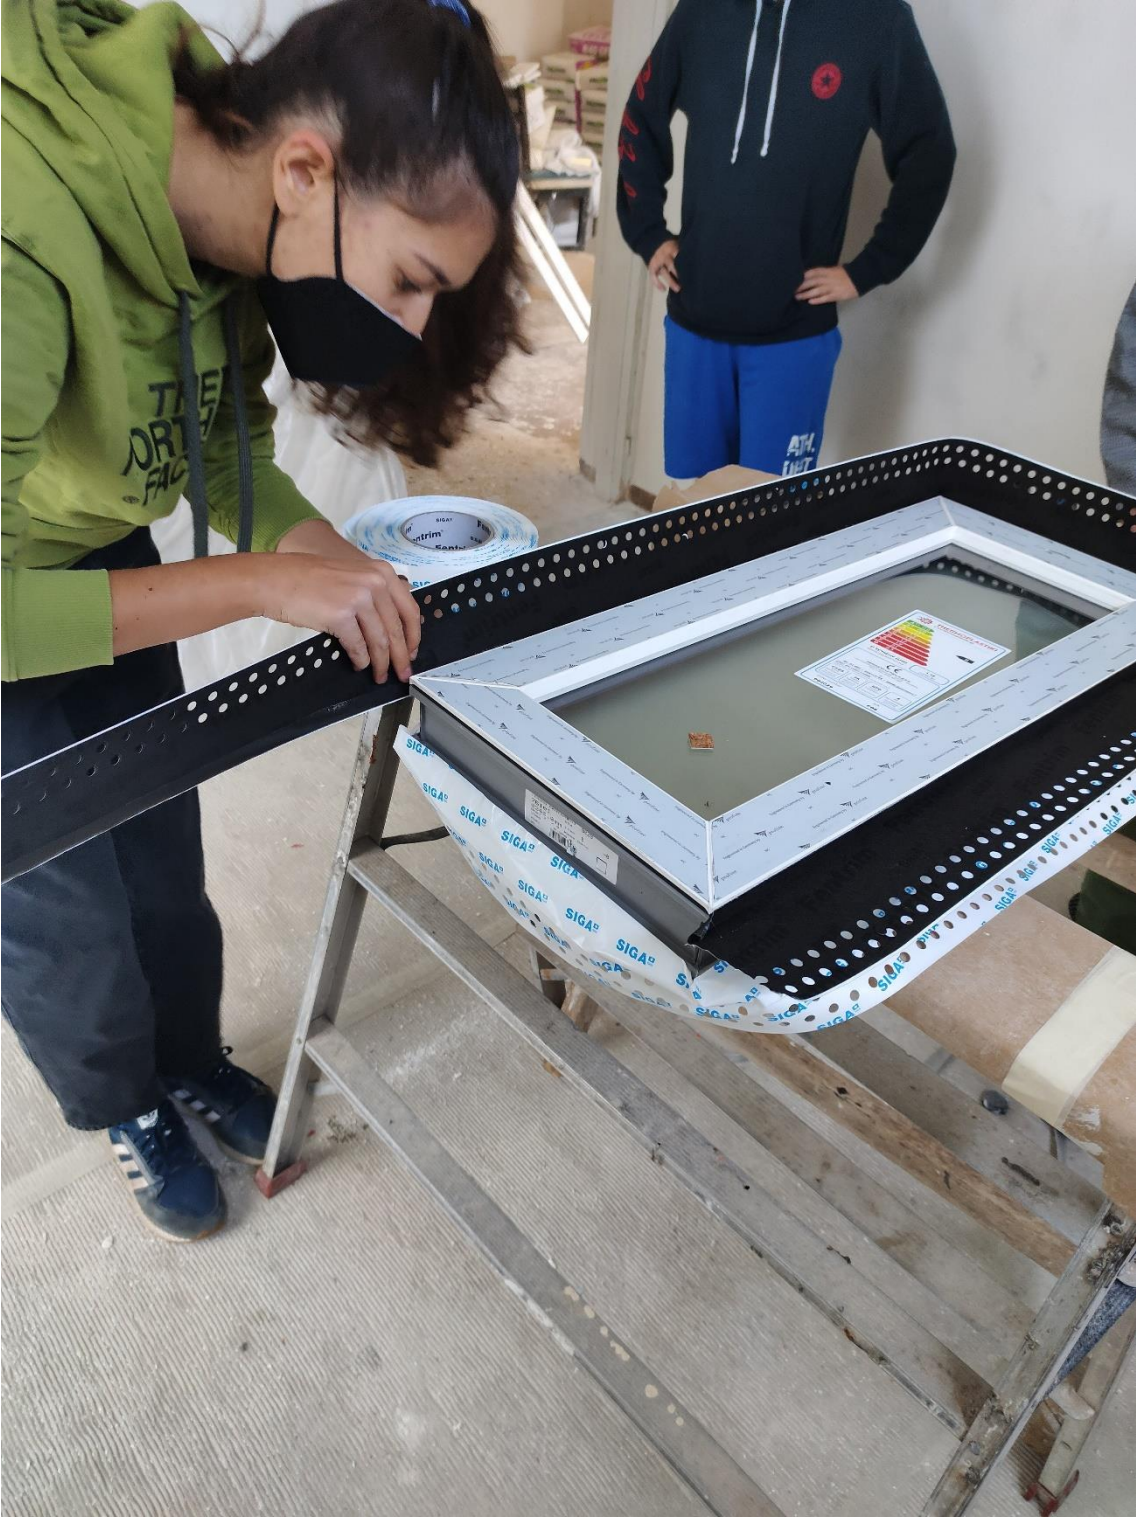
Figure 7 Installation of airtightness tapes

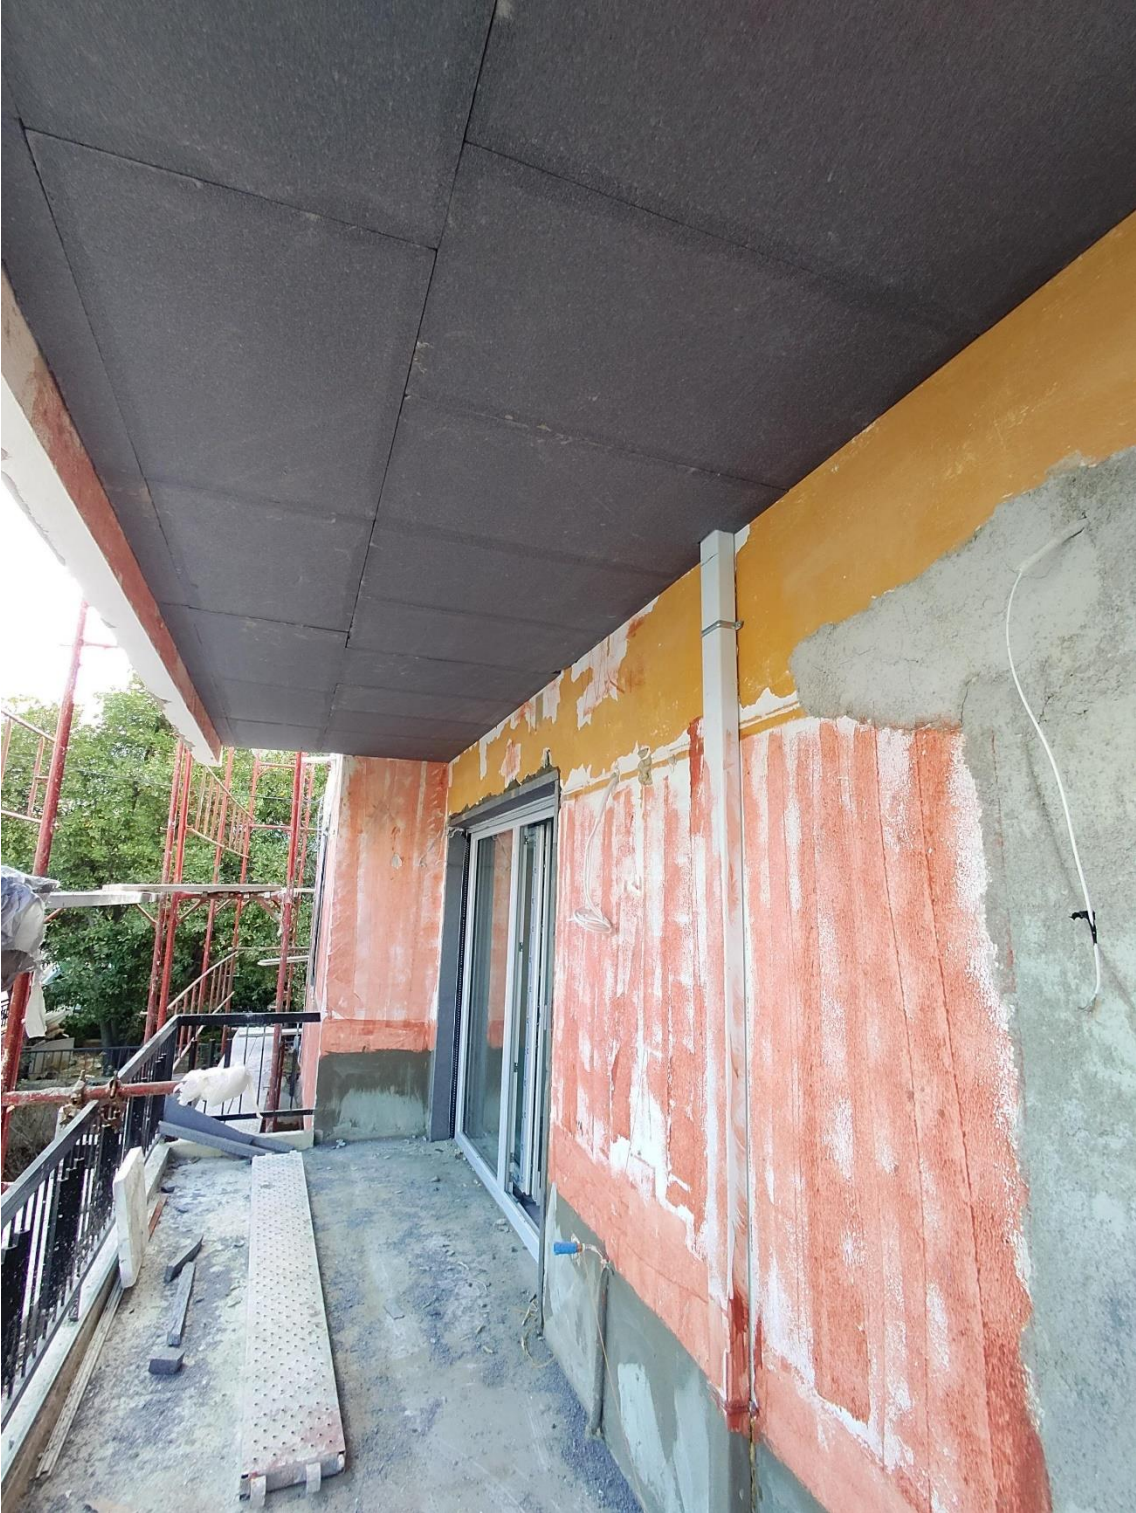
Figure 8 Installation of insulation in the down side of the extended roof

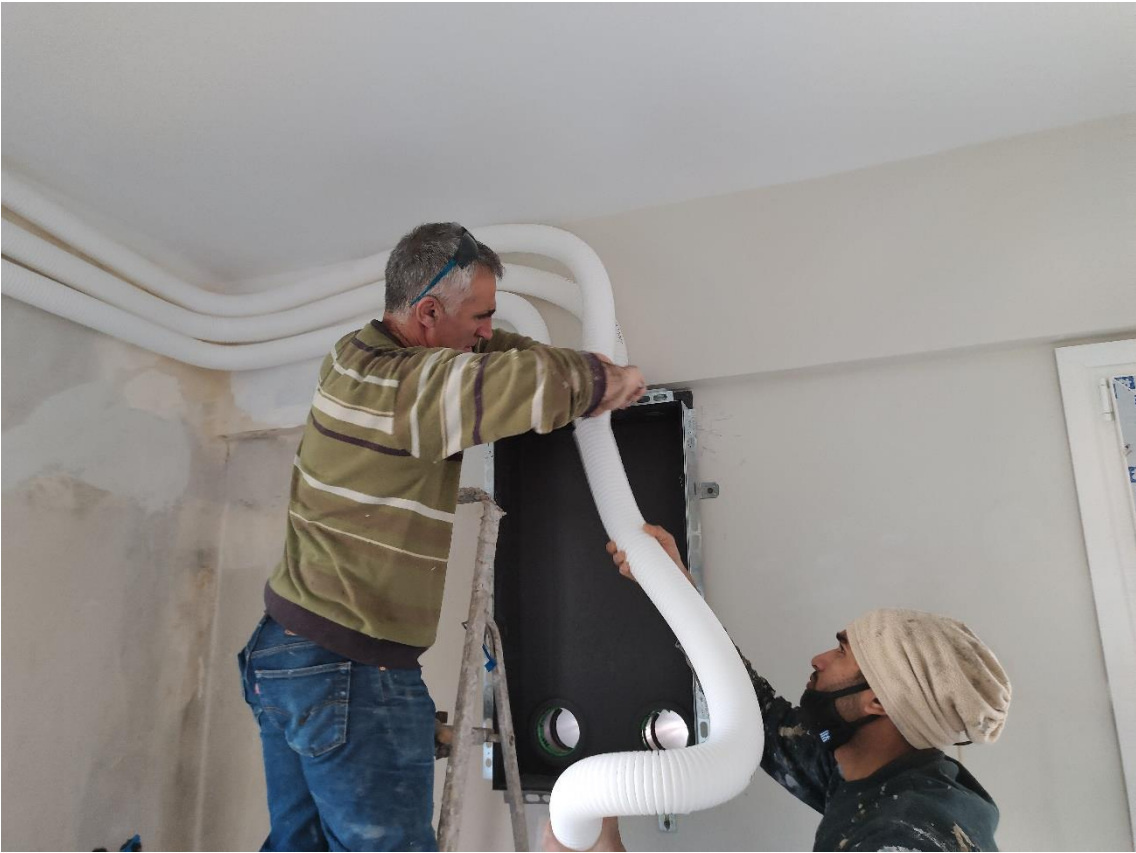
Figure 9 Installation of the MVHR and the air pipes

Ventilation concept (central / decentral)	Central MVHR
Ventilation heat recovery efficiency	82%
Ventilation specific efficiency	0.40[Wh/m ³]
Ventilation standard air flow rate	185[m ³ /h]

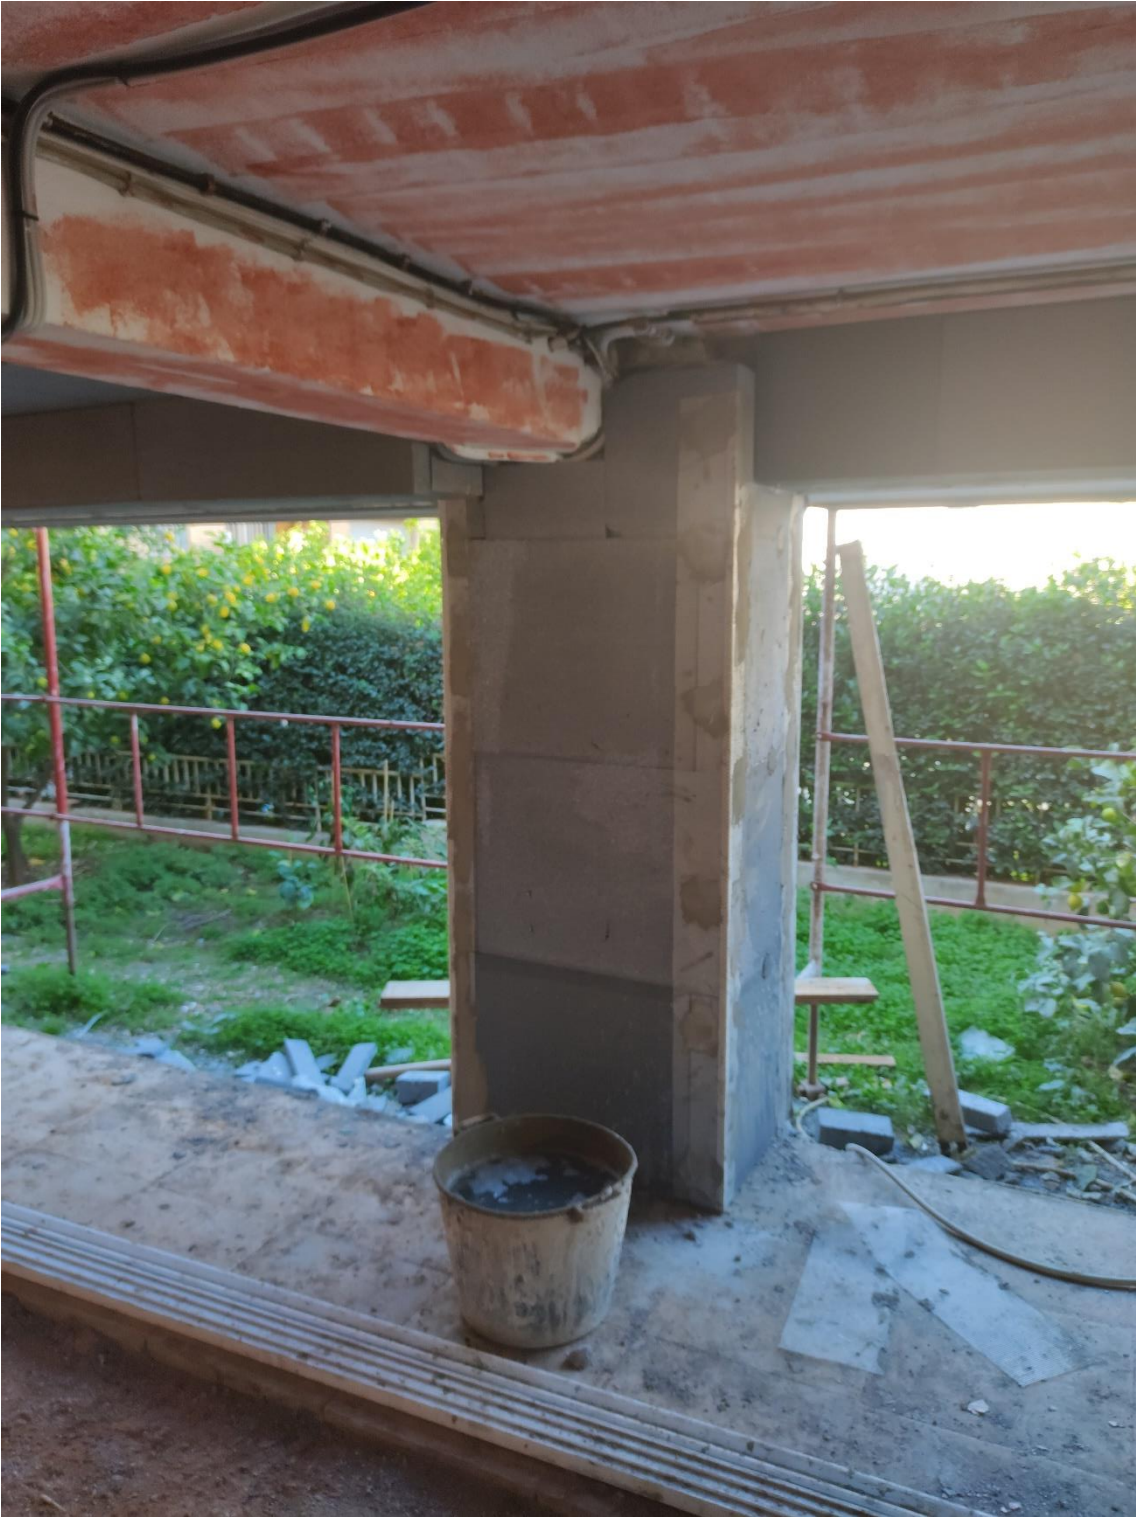
Figure 10 Eliminating the thermal bridges between the pillars and the pilotis

The challenges in this project were the elimination of the thermal bridges due to the high amount of pillars, columns and the pilotis. Also the big balconies that extend through the perimeter of the building.

The above challenges were eliminated by installing insulation in all the length of the pillars, through out all the pilotis surface as well as a block of insulation in the upper side of the balcony by removing a part of the cement screed.

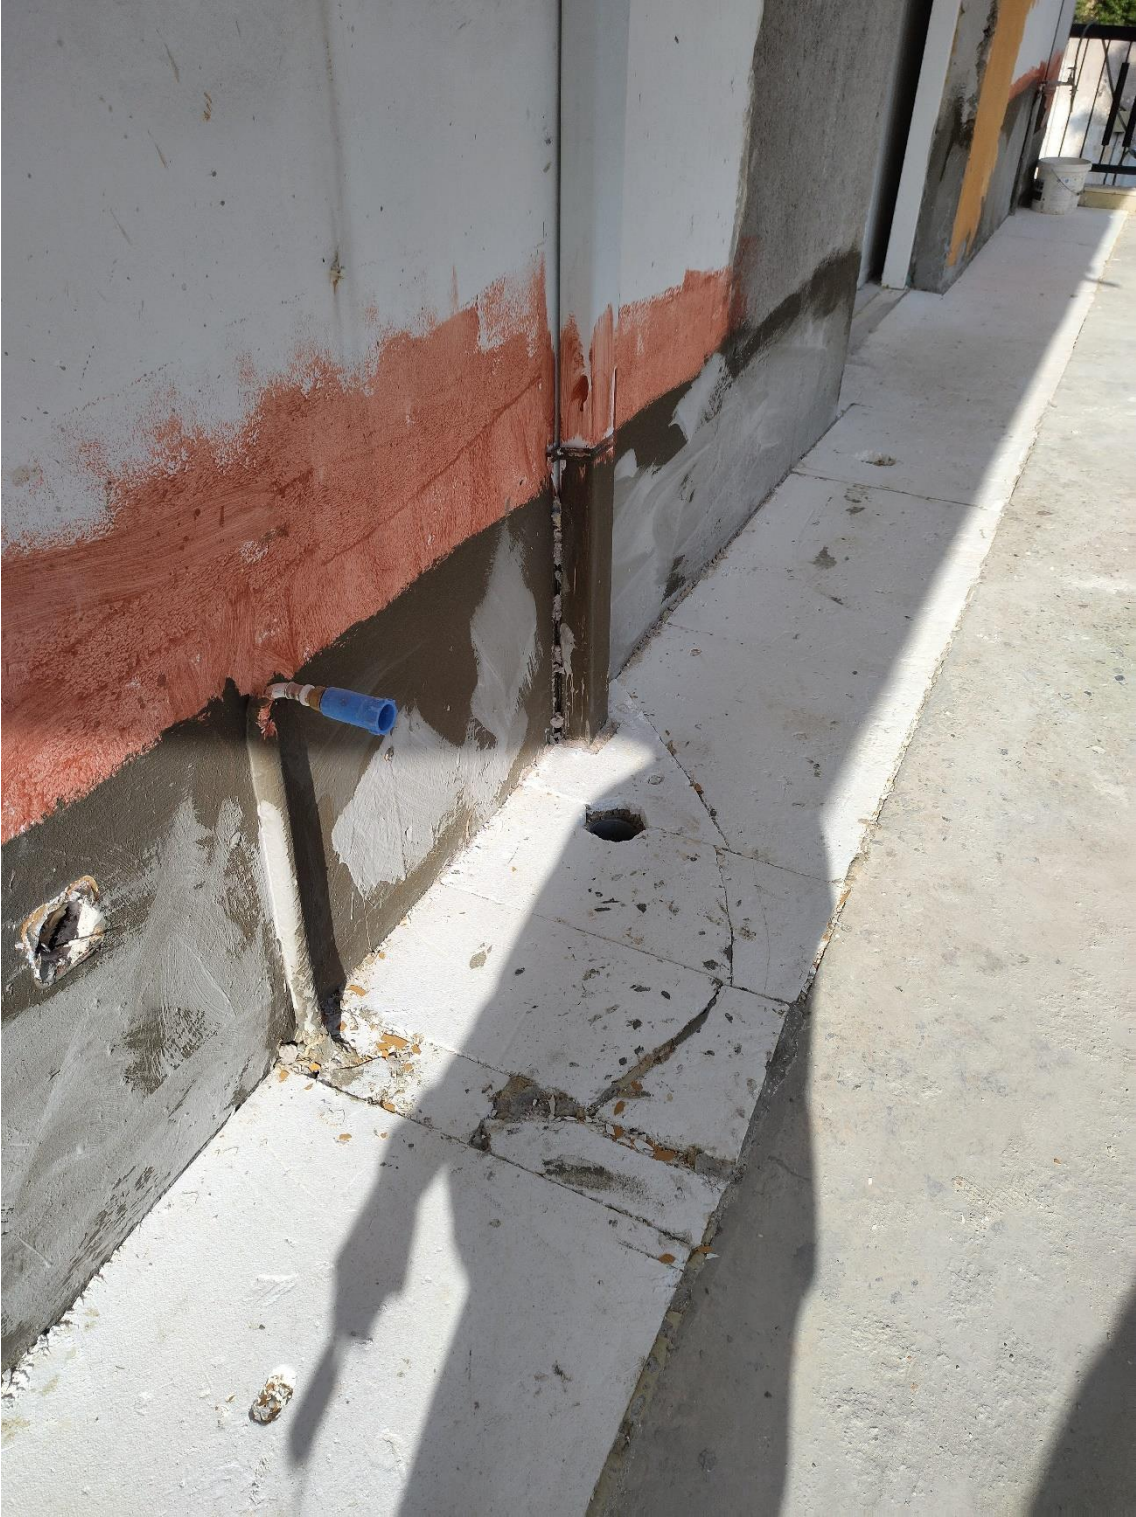
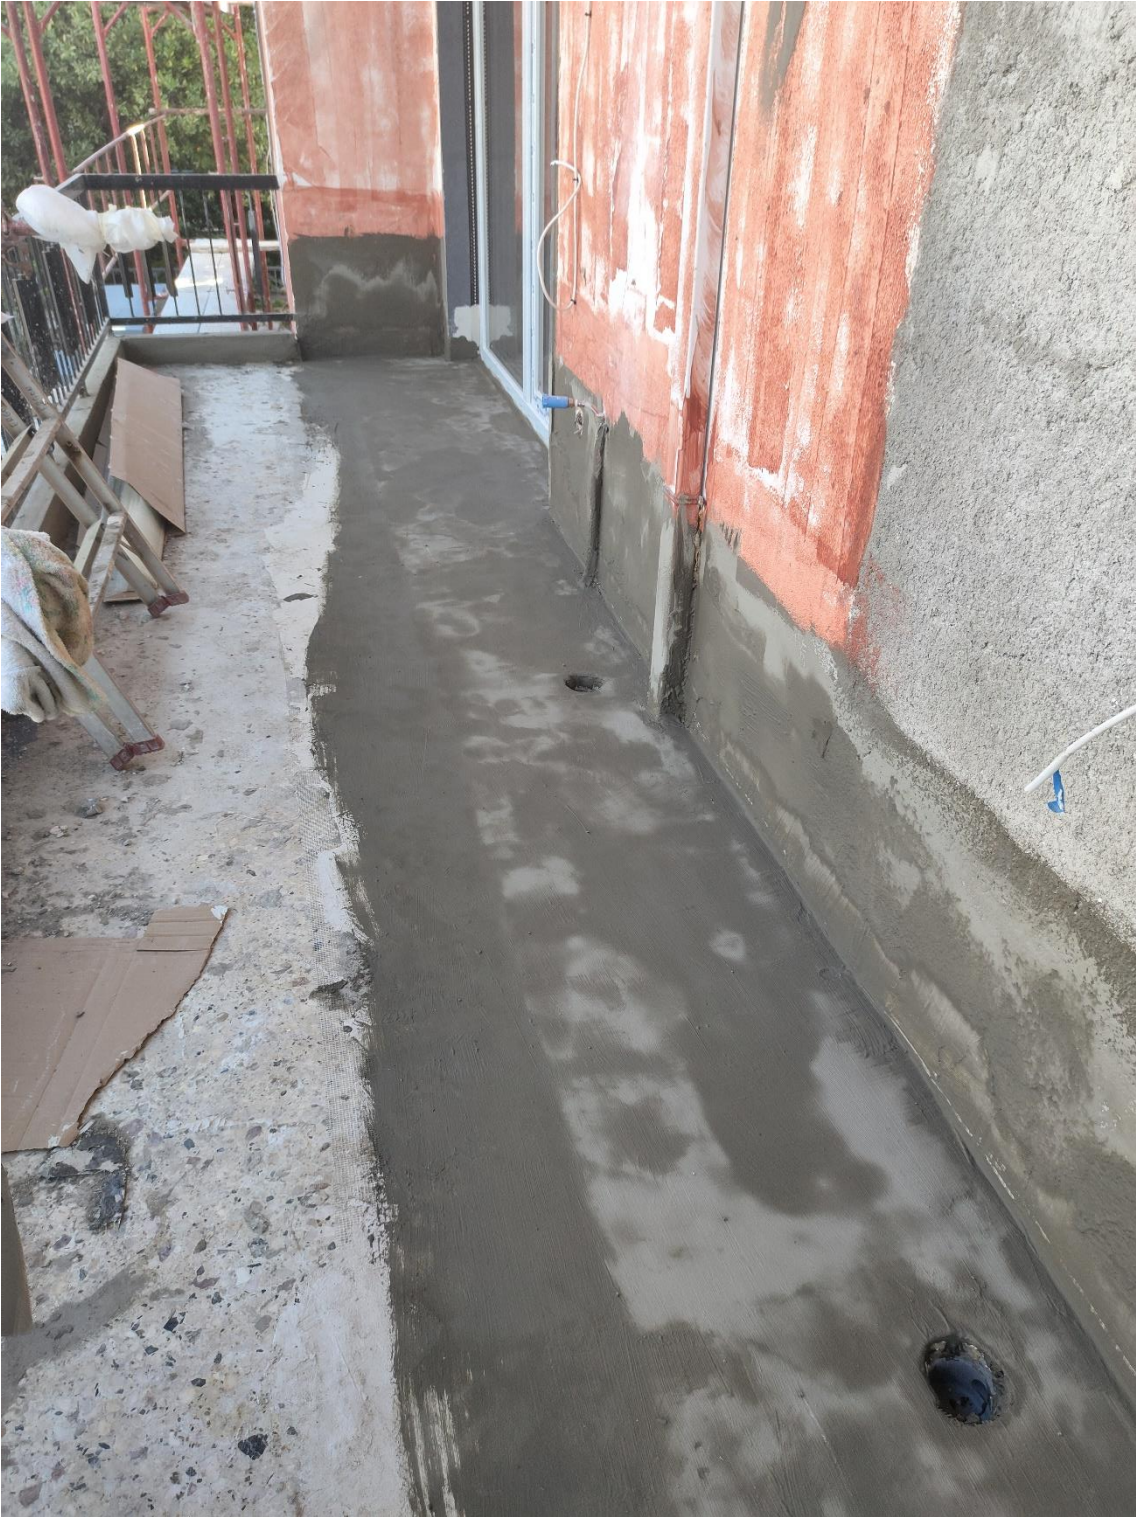
Figure 11 Installation of 60cm of insulation in order to minimize the thermal bridge in the balcony

Figure 12 Installation of 60cm of insulation in order to minimize the thermal bridge in the balcony
