CS22: (ATCS 01) ST03-BOZ11 in St. Johann, Tyrol

RENOVATION APPROACH DOCUMENT

Deliverable D5.2

Last updated 30. September 2022 by Harald Konrad Malzer; NEUE HEIMAT TIROL

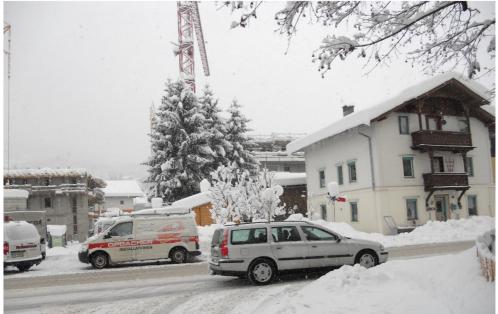
Photo of snowfall and typical winter conditions in Sankt Johann in Tirol; ©NHT

NHT construction sites have to be closed regularly in winter due to extreme weather conditions in Sankt Johann in Tirol. Photos above show approx. 90 cm of snow on the sloping roof and more than one meter at flat roofs.

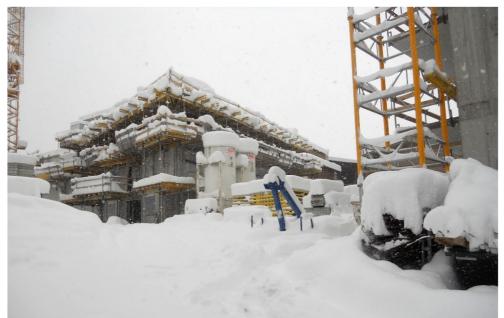
Photo of typical winter conditions in Sankt Johann in Tirol at the construction site of ST16-17; ©NHT

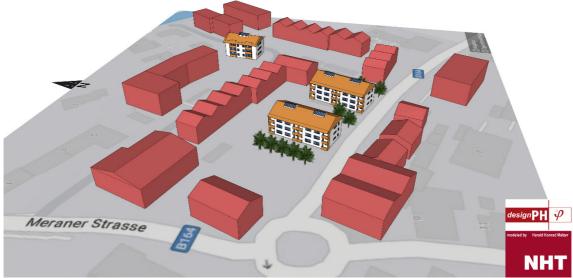
designPH 3D existing district ST03 – outPHit - Boznerstrasse 11, Fieberbrunner Str. 3 & 5:

Existing buildings of NHT building slot ST03; ©NHT/Malzer

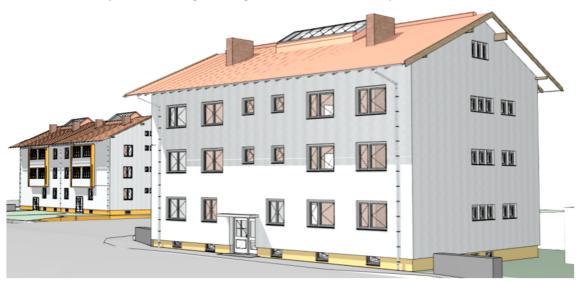
Architectural 3D-plan of existing building after detailed inventory:

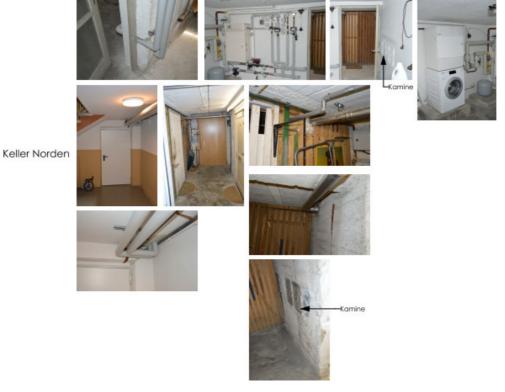
Inventory of existing building service installations within the basement:
