# CS 37: Single Family House Renovation Arheilgen / Darmstadt

# **RENOVATION APPROACH DOCUMENT**

Deliverable D5.2

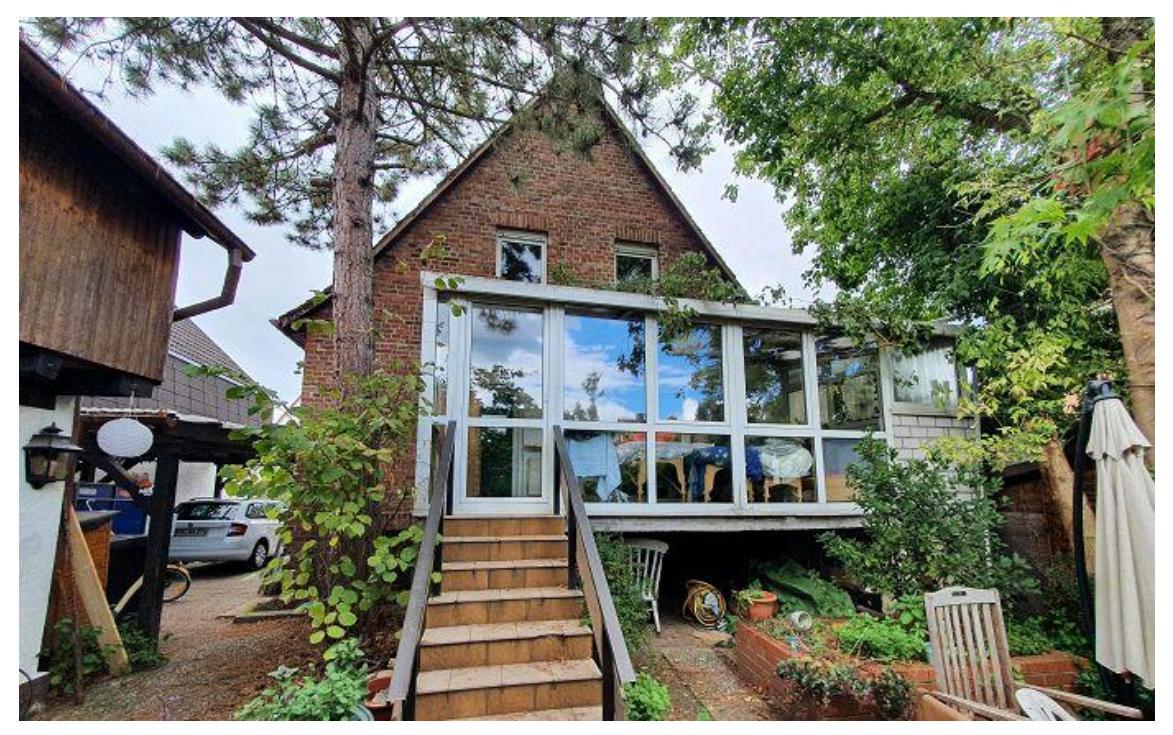
Back side with Wintergarden before renovation, Source: PHI

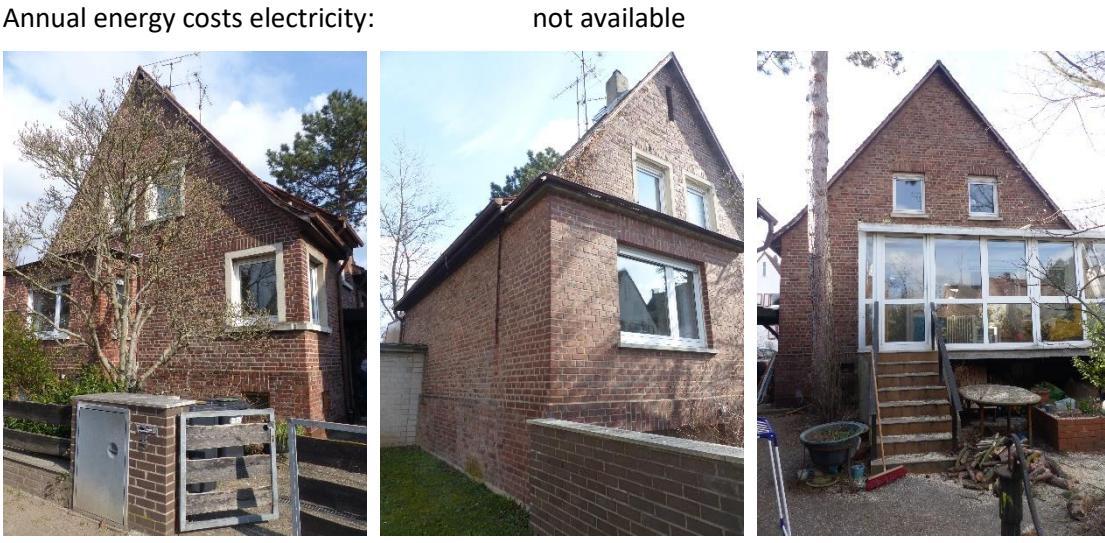
Existing Brick Wall Facade, Source: PHI

External walls	
Material:	Brick wall
Thickness:	28 [cm]
Surface (Render / Brick / Cladding):	Brick wall
U-Value:	1,70 [W/(m²K)]

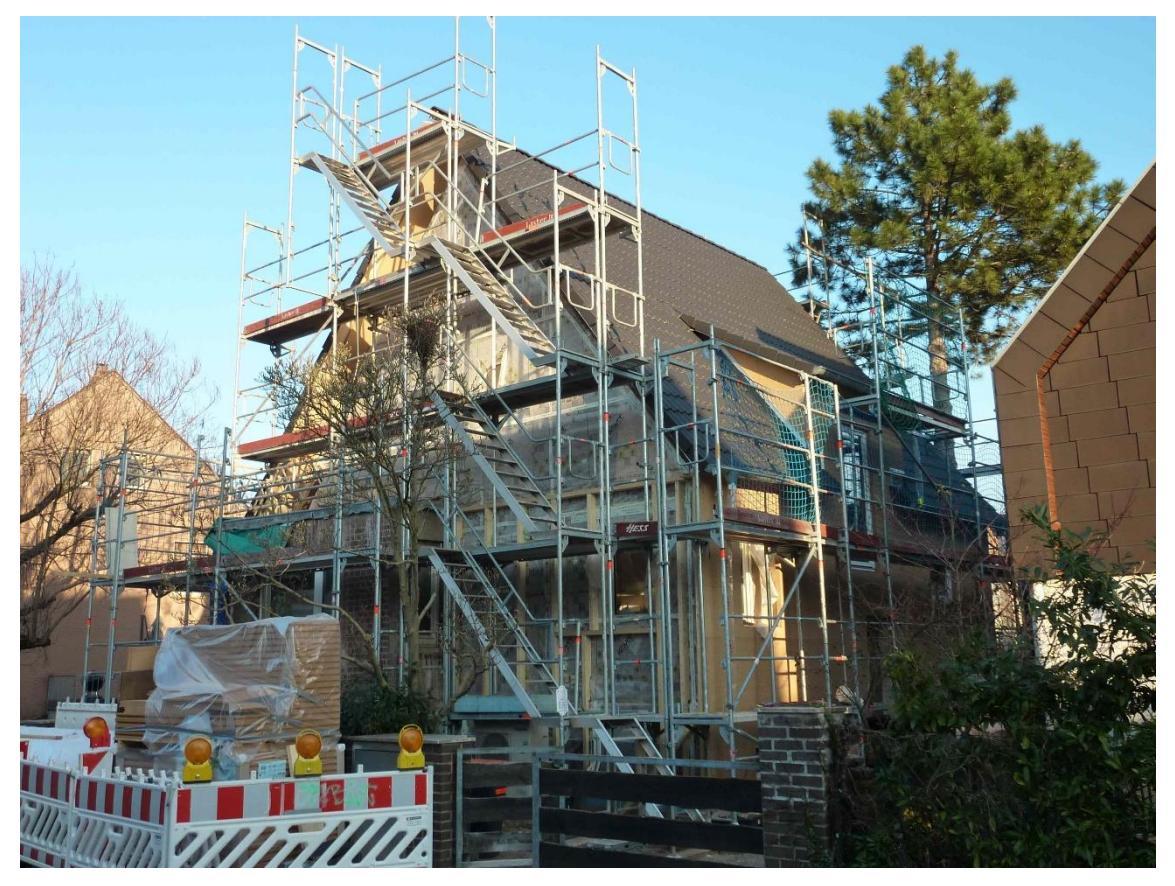
Street façade during the renovation of the building, Source: PHI

The building envelope of this small building was renovated by intention using on-site small scale insulation parts. The main reason to do so was the small scale dimensions of all wall and roof areas: no part of the building was similar to any other. So the wooden beams which build-up the cavity for the cellulose fiber filling were provided individually on top of the old rafters and all along on the outside walls. On top of the new beams a 6 cm wooden fiber board was installed to close the cavity. All windows were then installed on these beams, which formed a 'perfect' installation frame so that the windows could be moved out into the insulation layer, see the photographs below. Nevertheless the conception and the construction system is straight forward routine, not at least to provide a good airtight shell without

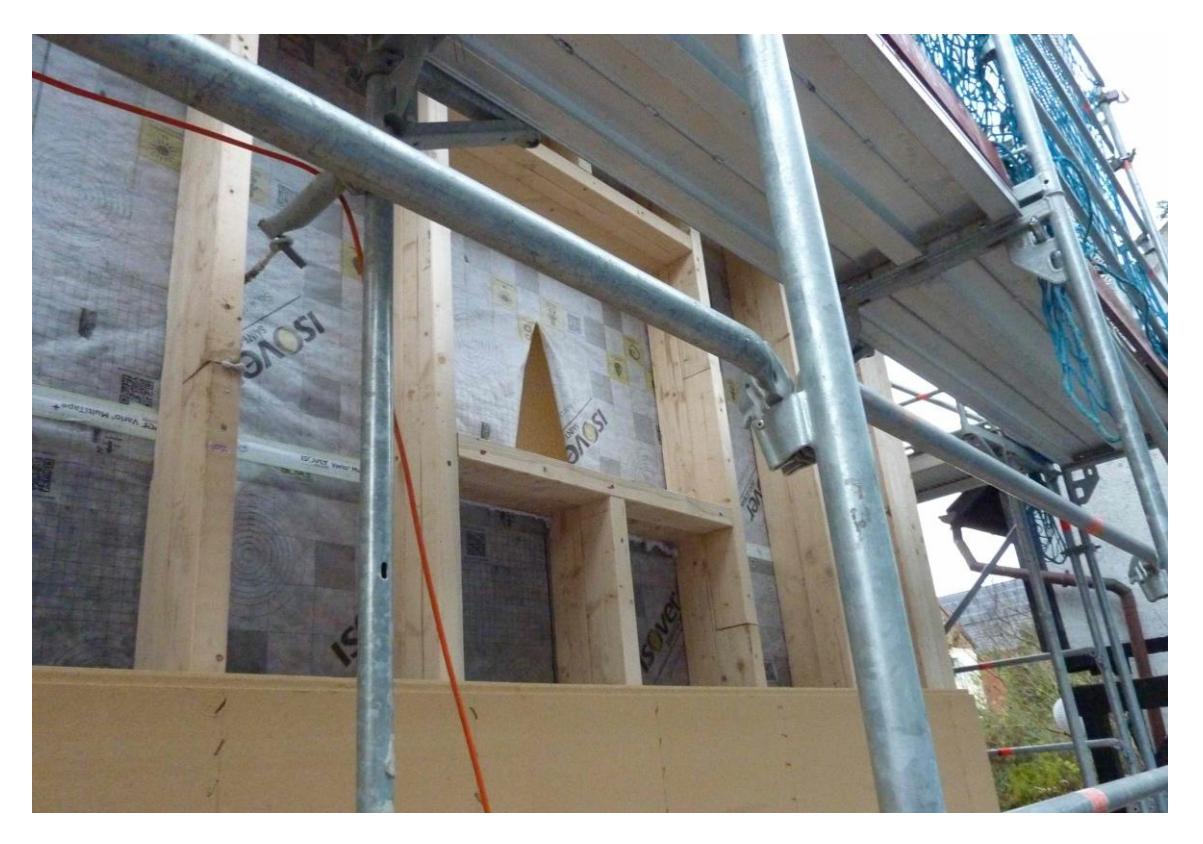
Stud wall façade with wood fiber boards before cellulose filling. Windows to be installed later into these wooden beam frames. Source: PHI

External walls	
Material:	Stud wall with cellulose filling and wood fibre board $% \left( {{{\mathbf{x}}_{i}}} \right)$
Thickness:	24 [cm] / 6 [cm]
Surface (Render / Brick / Cladding):	Wood lamellas
U-Value:	0,14 [W/(m²K)]

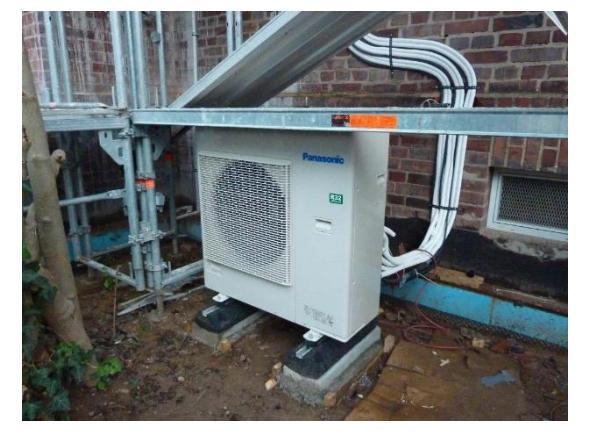
Heat pump and split unit during the installation, Source: PHI

Heating, Cooling and DHW	
Heating:	1 air-water heat pump
Cooling:	Active cooling with split unit
Domestic hot water:	1 air-water heat pump

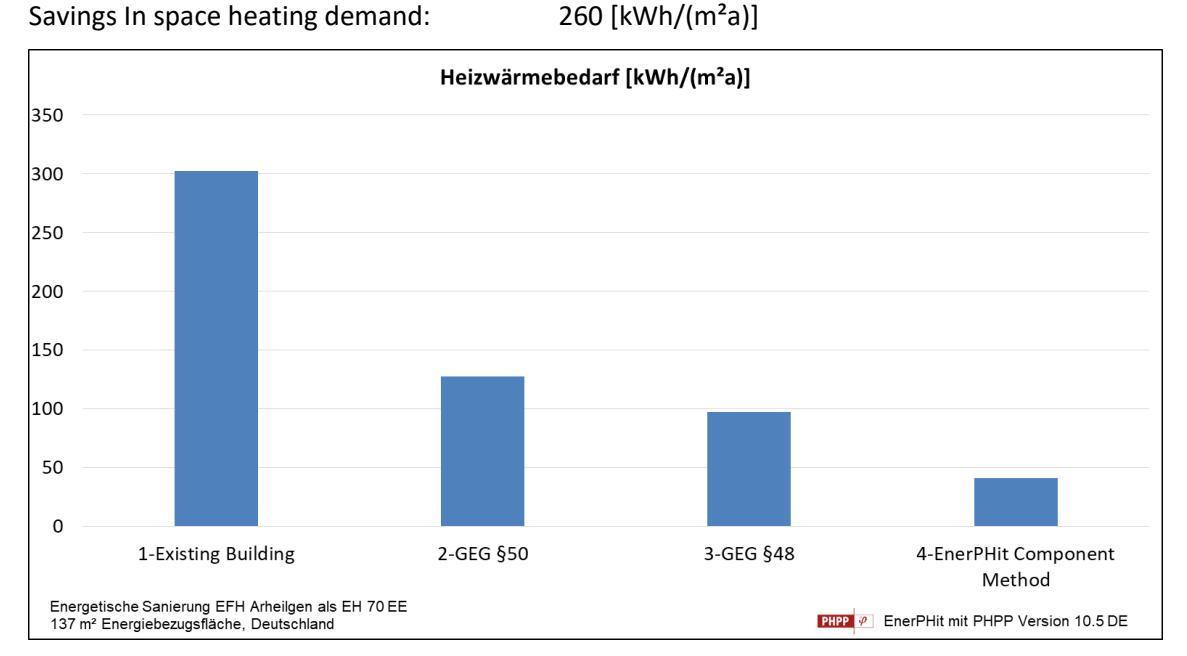
Heating demand before and after the renovation [PHPP 10.5] / Source: PHI

The two minimum requirement standards for Germany, fulfilling a minimum PE-demand approach according to GEG §50 or fulfilling a minimum component quality approach according to GEG §48 have also been modelled. Clearly visible is the considerable higher heating demand reduction enabled by the EnerPHit standard.

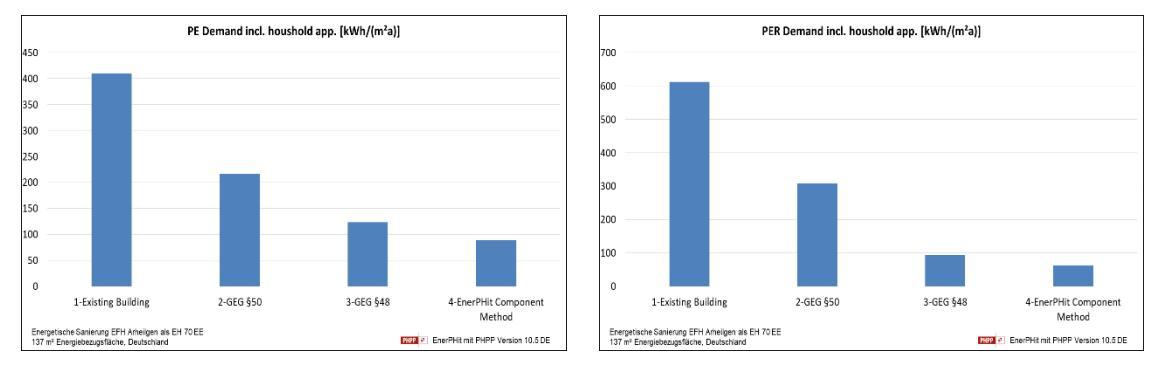
**Primary Energy PE Demand and Primary Energy Renewable PER Demand of the building before and after the renovation [PHPP 10.5]** The PER demand simulates a future energy supply environment (for example 2050), when most of the energy generation will be renewable and considerable storage losses will have to be expected, especially for seasonal energy storages, that will be required for heating / Source: PHI

Savings Primary Energy Demand:

Savings PER Demand:

319 [kWh/(m<sup>2</sup>a)] 549 [kWh/(m<sup>2</sup>a)]

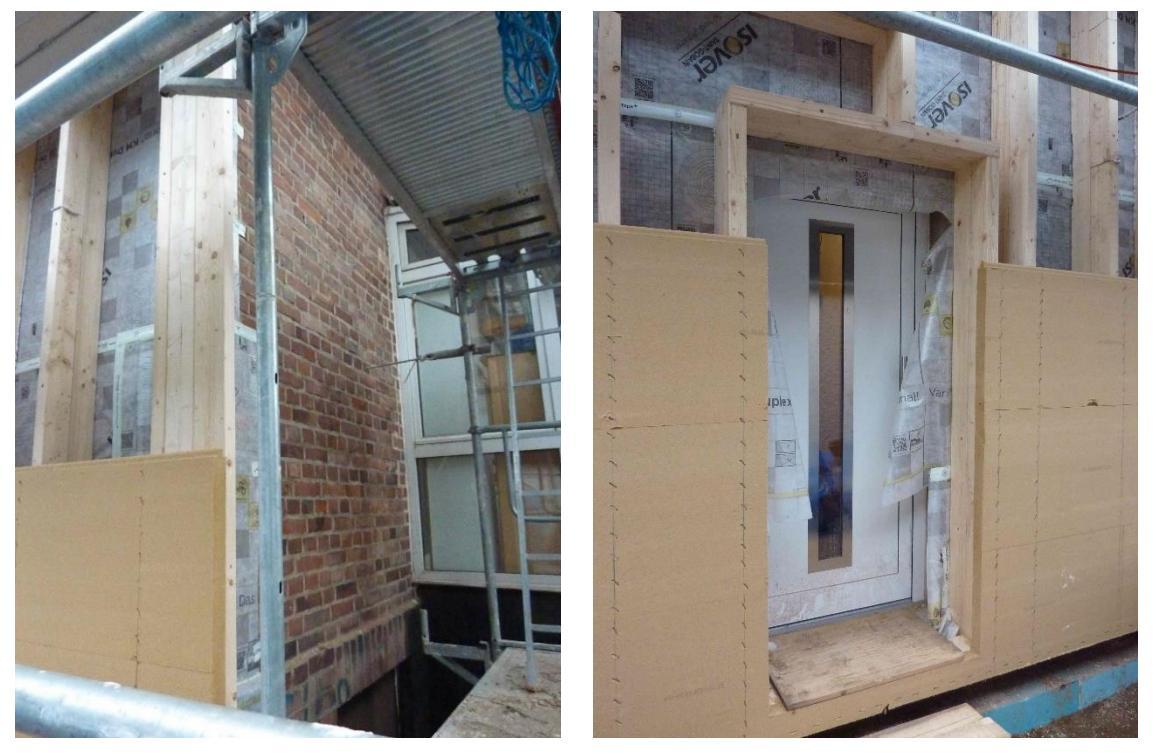
Old brick wall with stud wall system / Source: PHI

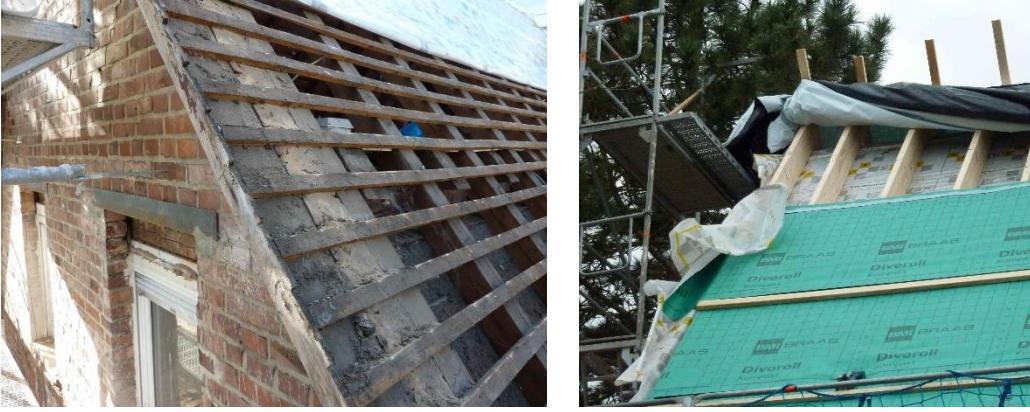
Old and renovated roof situation / Source: PHI

Material:	Mineral fibre / Cellulose filling / wood fibro board
Thickness:	12 [cm] / 24 [cm] / 6 [cm]
Surface (Render / Brick / Cladding):	OSB planking
U-Value:	0,11 [W/(m²K)]
